January 12, 2001

Captain Mohsen El Missiry  
Chief of Egyptian Investigation Committee

Response of EgyptAir  
to  
October 31, 2000 Submission of  
The Boeing Company  
Regarding  
The EgyptAir Flight 990 Investigation

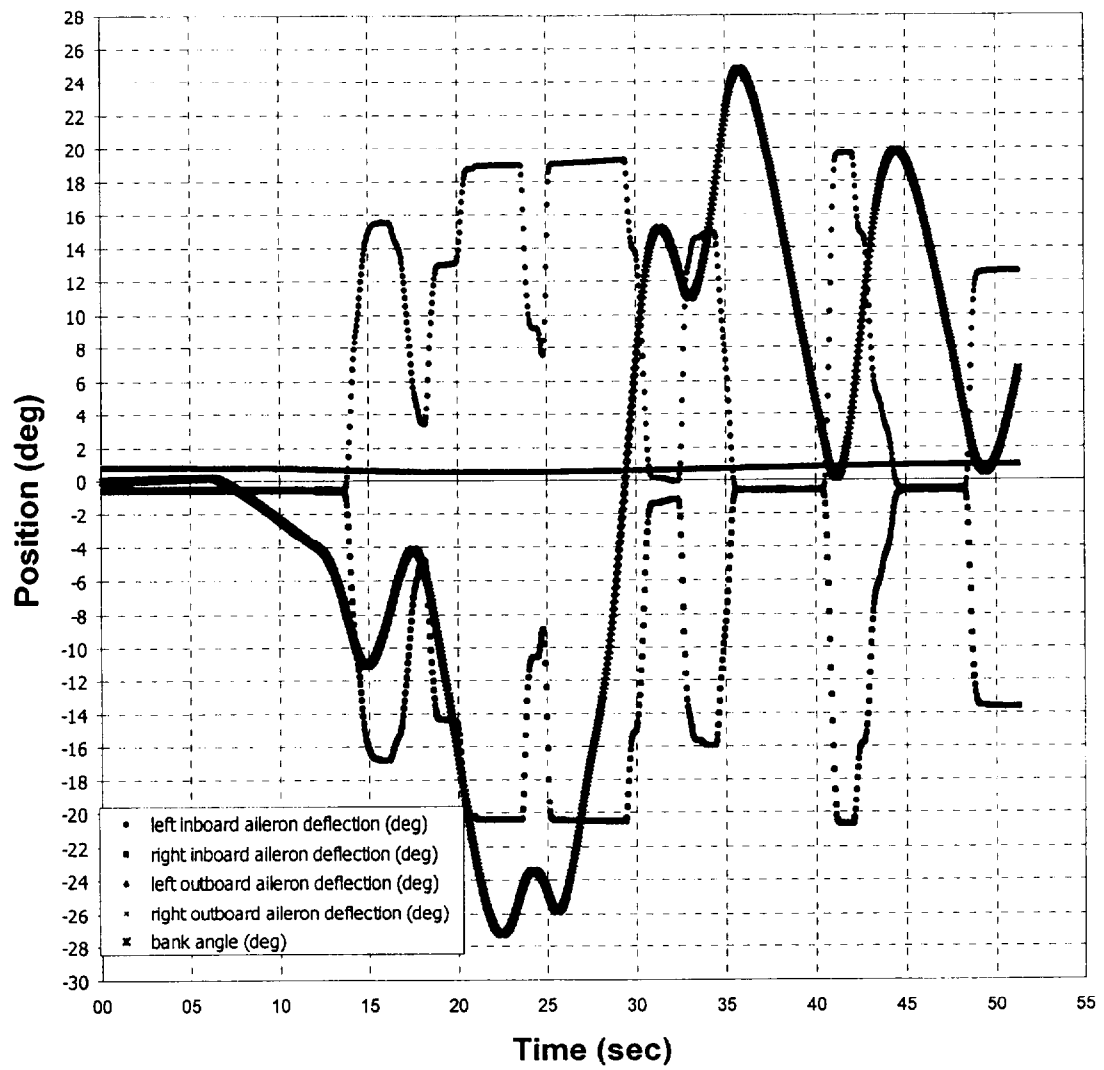
Figure 12. Aileron Deflection and Bank Angle from Data Recorded at the Second E-Cab Simulation Session

The effect of the pitching moment due to differential elevator deflection was also supported using data gathered during the second session of E-Cab simulations. During the second session, the programming of the simulator had been changed to allow differential elevator deflection. Plots extracted from the data recorded at the second E-Cab simulator session are shown in Figures 12 and 13. This example was recorded during a run in which the right elevator was deflected down approximately 5.5 degrees of right elevator deflection and the left elevator left to pilot control. Notice that differential aileron deflections of over 40 degrees are needed to keep the roll angle near zero. During the time of the alleged split elevator, the maximum differential aileron deflection recorded on the FDR was approximately 13 degrees (with the exception of one second at almost 20 degrees) and the average was about 6.5 degrees. These results can only be explained if the elevator did not actually produce the calculated rolling moment. Further, the positive load factor that was recorded on the FDR was due to the position

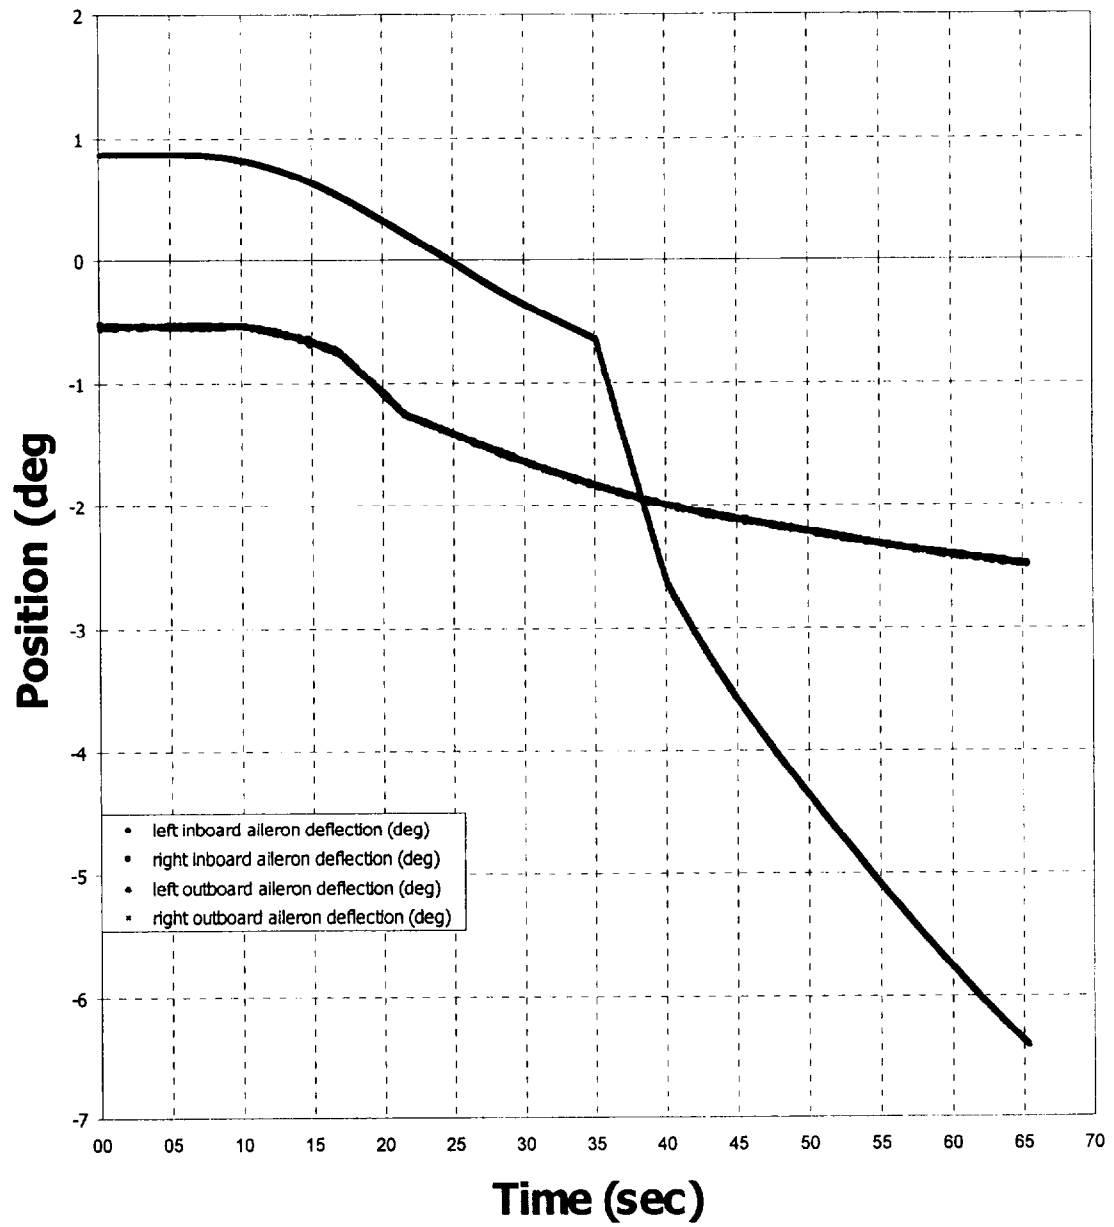
Figure 15. Aileron Position from B-767 Ground Test Results Extracted from Boeing CD

- The E-Cab data produced an unrealistic relationship between control wheel force and wheel movement (see Figure 14) and showed the movement of the outboard ailerons at speeds beyond the lockout speed (see Figure 15).

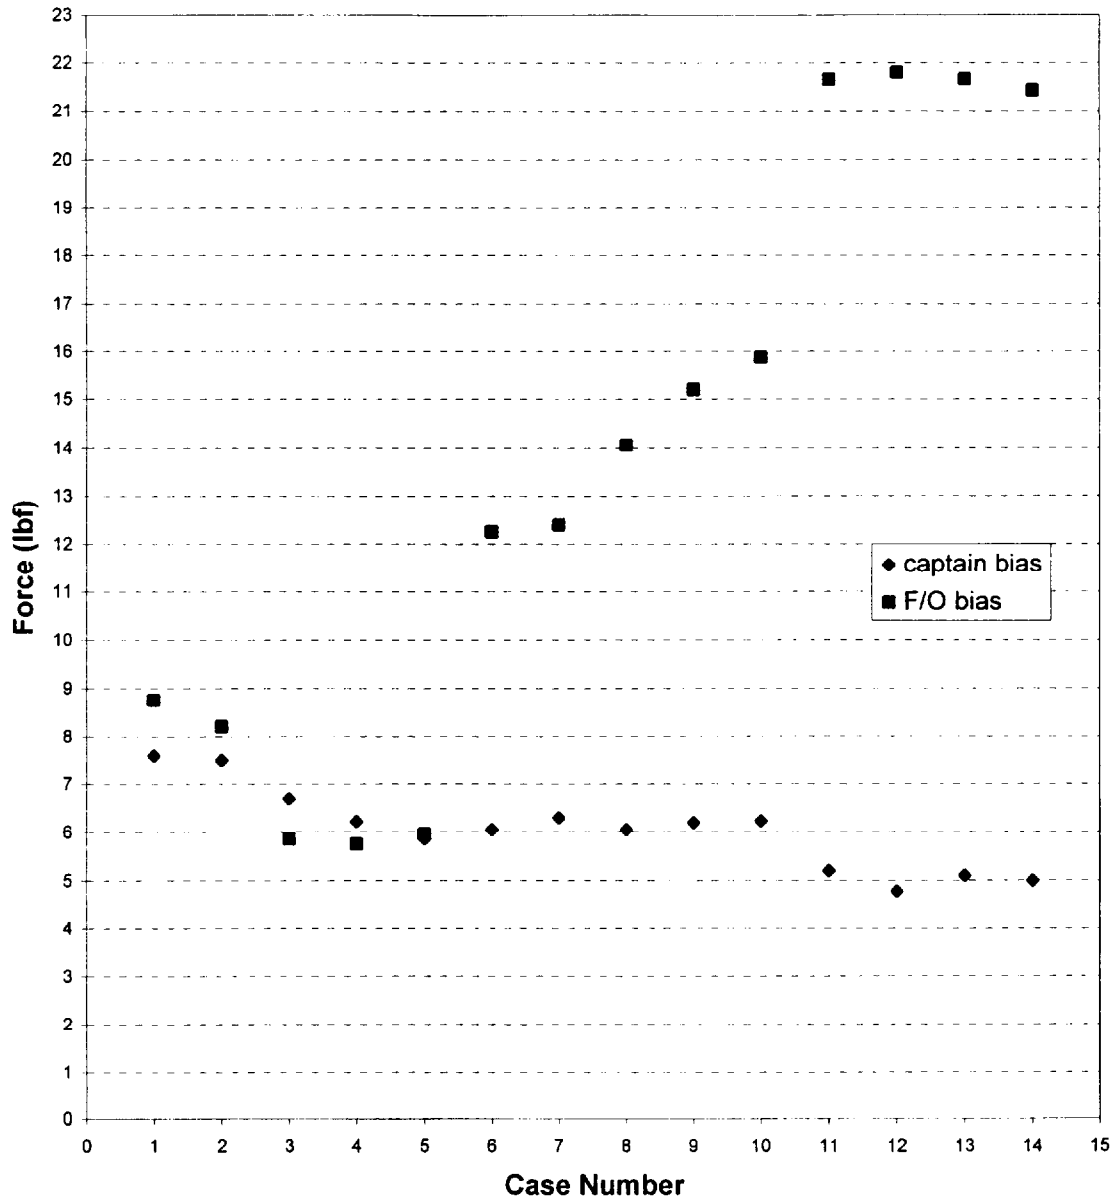
Figure 25. April Ground Test Data, Bias Changes for Captain and First Officer Column Force Measurements

Figure 25 shows the bias during another test, but this time, the bias on the First Officer's force measurement increases much more rapidly than in the earlier test. This suggests that the temperature effects on the transducers are random because the temperature dependence more than triples between tests. Even if the temperatures had been recorded during the tests, that
